Subject: Determination on Permitting Requirements, Charleston Pit, Wasatch County, Utah

SUBJECT: Geology of the Charleston pit

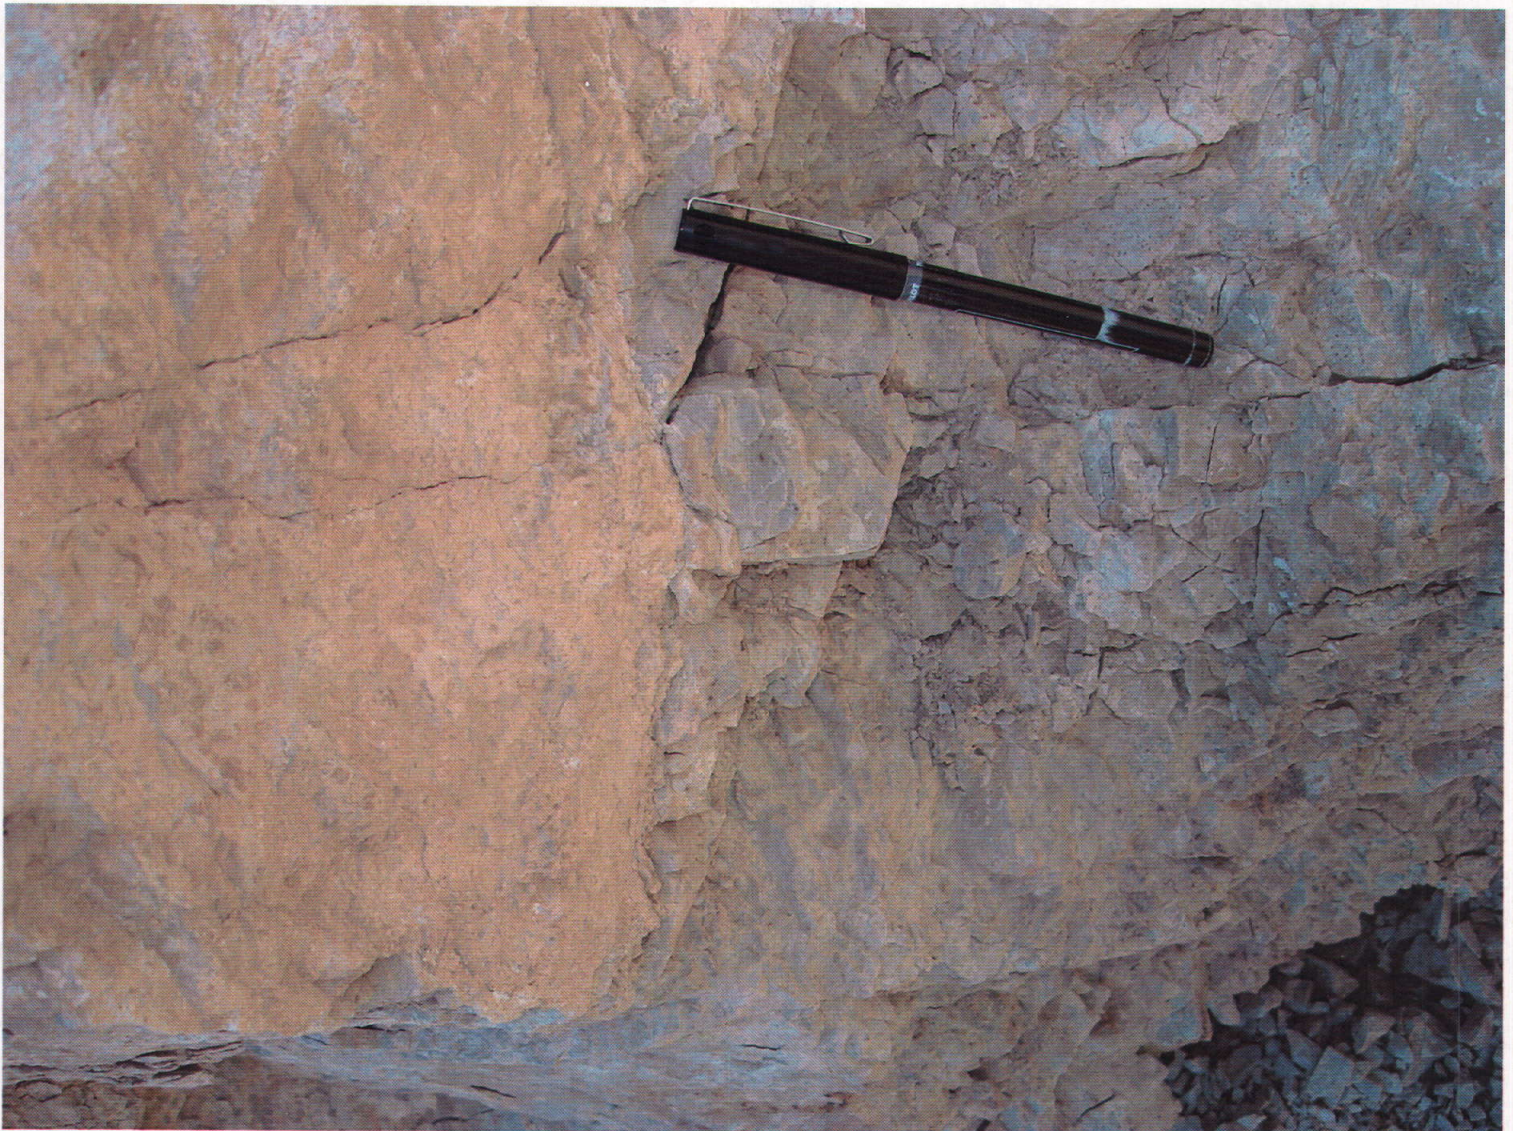
Figure 3. Fractured sandstone at point 2 on figure 2 (note pen for scale).

I consider all of the sandstone in the pit to be bedrock because it is consolidated and is in place in coherent beds (figures 3-5). Outcrops across the pit have similar strikes and dips. There is no evidence that any of the material being mined has been eroded, modified, or transported by recent alluvial processes. Also, there is no geologic evidence to indicate that the material being mined is "rock aggregate".

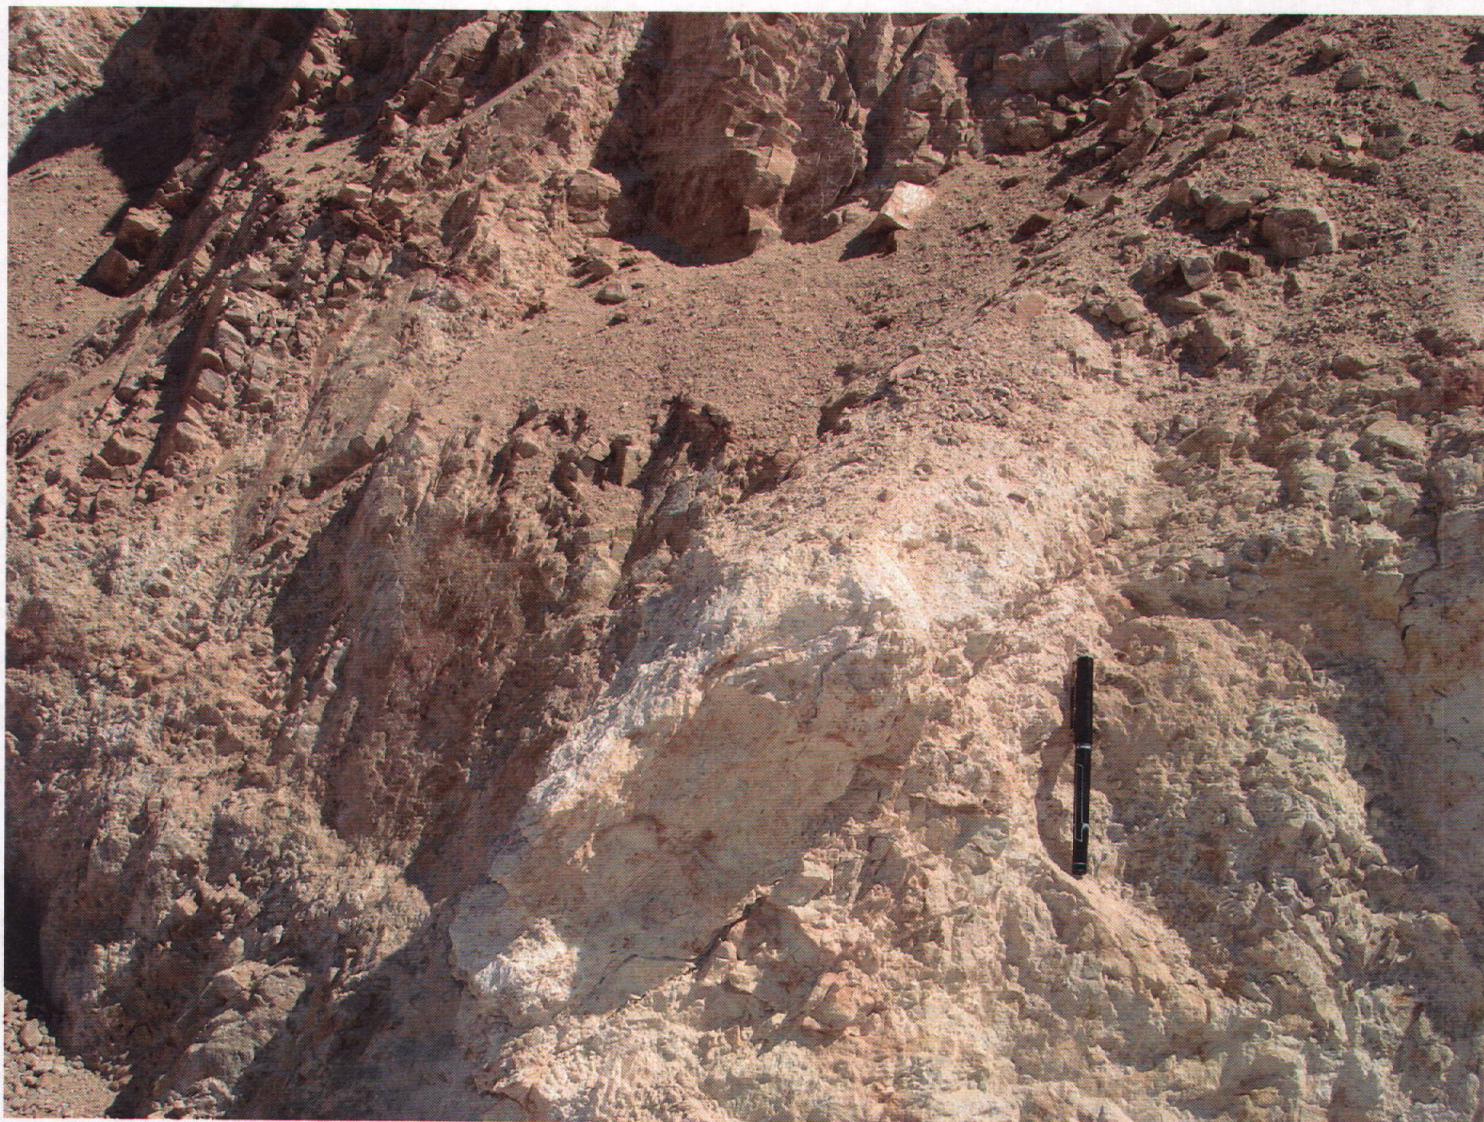
Figure 4. Fractured tan sandstone showing gouge development along local fracture (location 3 on figure 2).

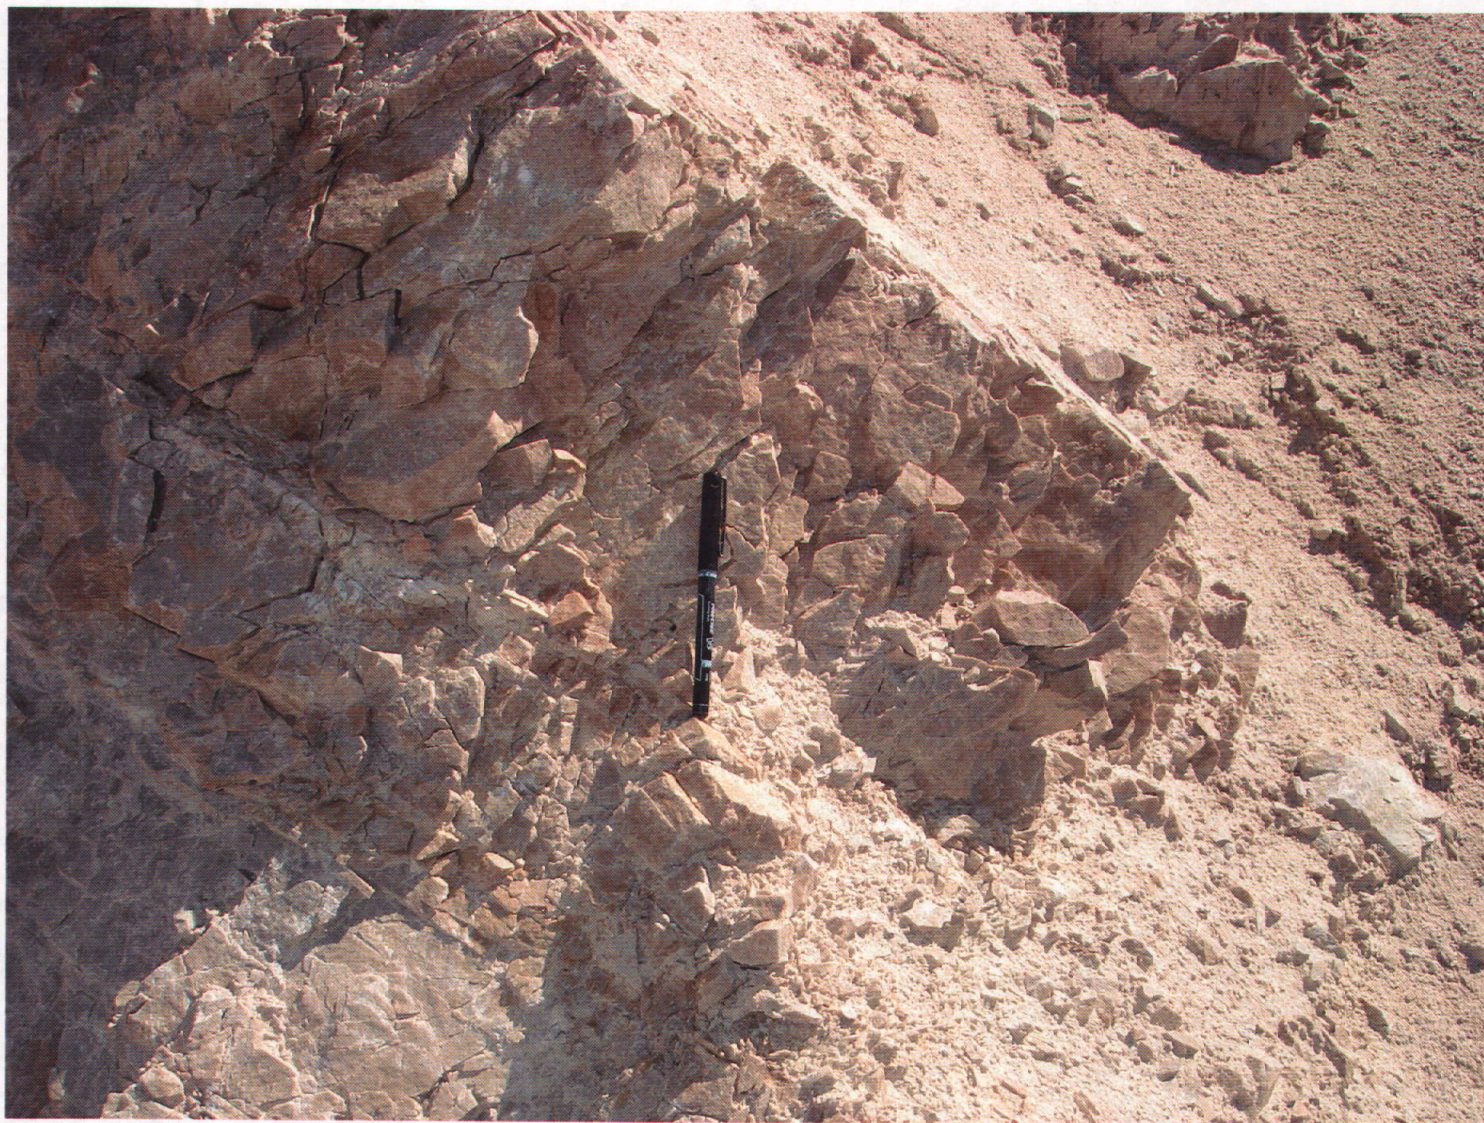
Figure 5. Tan fractured sandstone at location 4 on figure 2.
